Princip och tillämpningar av aktiv vibrotemografi

Tadeusz Stepinski, *Uppsala universitet*
Mariusz Szwedo, *MONIT, Kraków, Polen*

FOP Temadagar på Högskolan Väst i Trollhättan
den 13-14 november, 2012

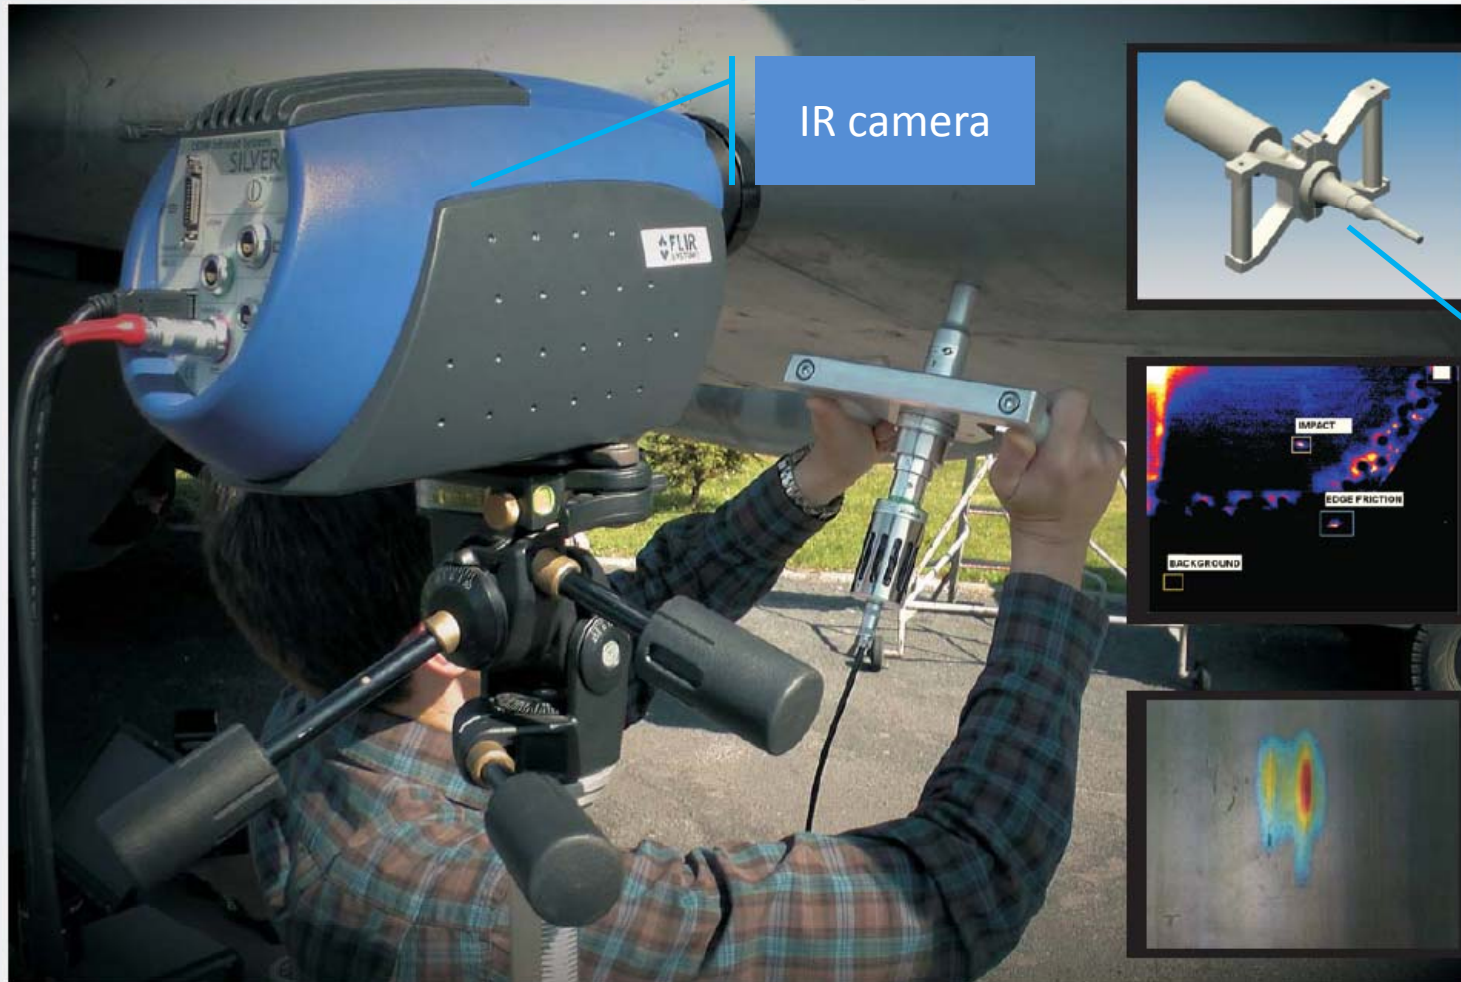
Active thermography with ultrasound excitation

Handheld instrument

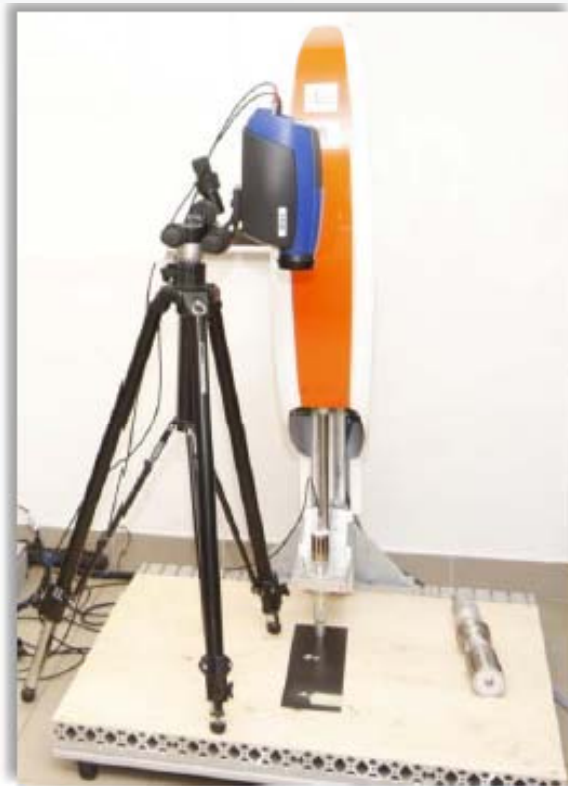
Active thermography with ultrasound excitation

Laboratory instrument

with pneumatic control of the clamping force between
excitation module and tested component.

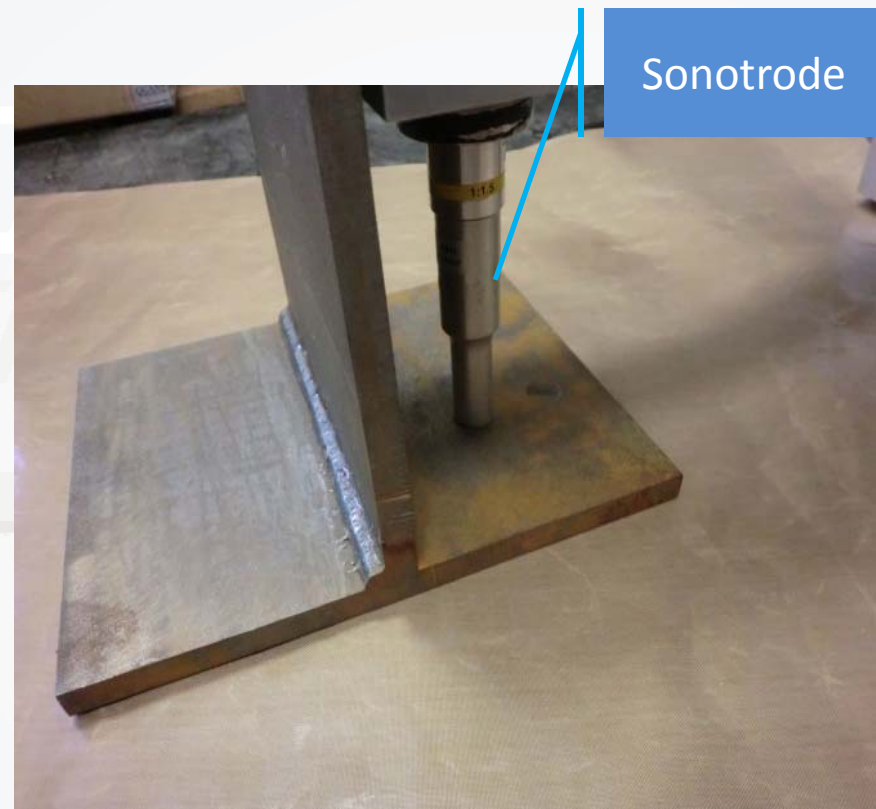
Example of flaw detection in carbon steel weld test specimen

Weld test specimens – cold laps in weld

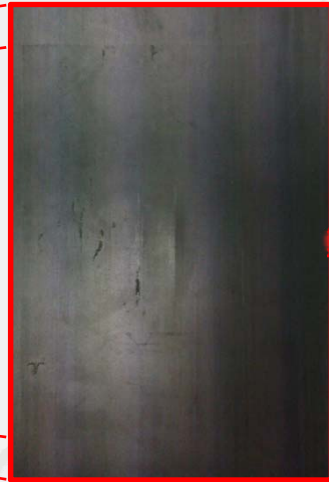
Damage identification in carbon epoxy plate

Vibrothermography

Identified damage
